HEADLANDS TRAIL IMPROVEMENTS

MAY 23, 2022

PHASE ONE PLAN VIEW

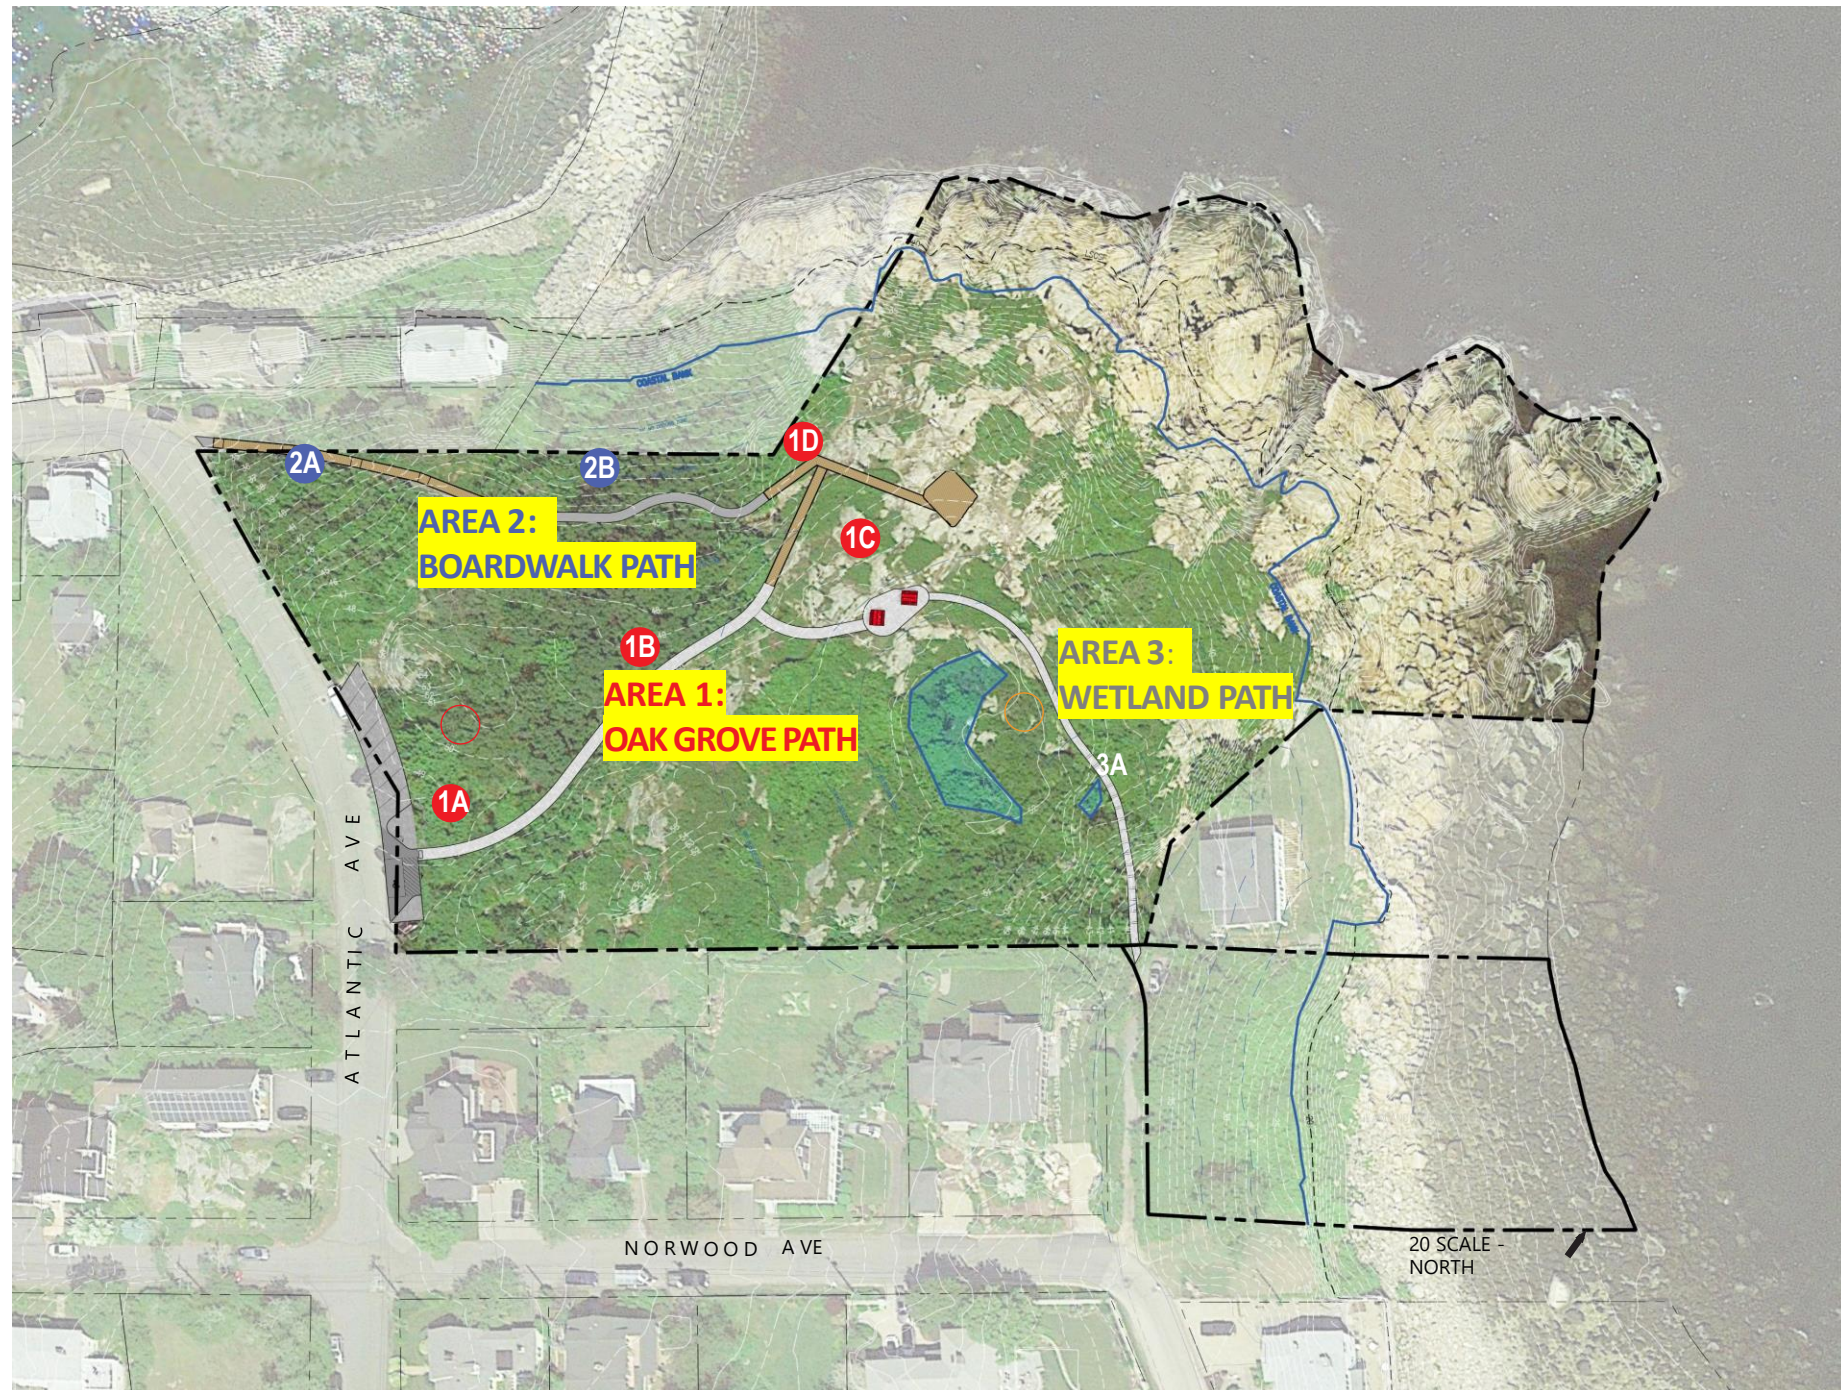
OVERALL PLAN VIEW

LEGEND

AREA 1: OAK GROVE PATH

- 1A ENTRY SIGN / CRUSHED STONE
60 DEGREE PARKING
- 1B STABILIZED STONEDUST PATH
- 1C STONEDUST SURFACING
PICNIC AREA (FUTURE YEAR)
- 1D 5' WIDE COMPOSITE
BOARDWALK W/WOODEN
KICKRAILS & EDUCATIONAL
SIGNAGE (FUTURE YEAR)

AREA 2: BOARDWALK PATH

- 2A 5' WIDE COMPOSITE BOARDWALK
W/WOODEN KICKRAILS
- 2B ASPHALT PATH

AREA 3A: WETLAND PATH (FUTURE YEAR)

STABILIZED STONEDUST PATH
WITH WOODEN STEPS

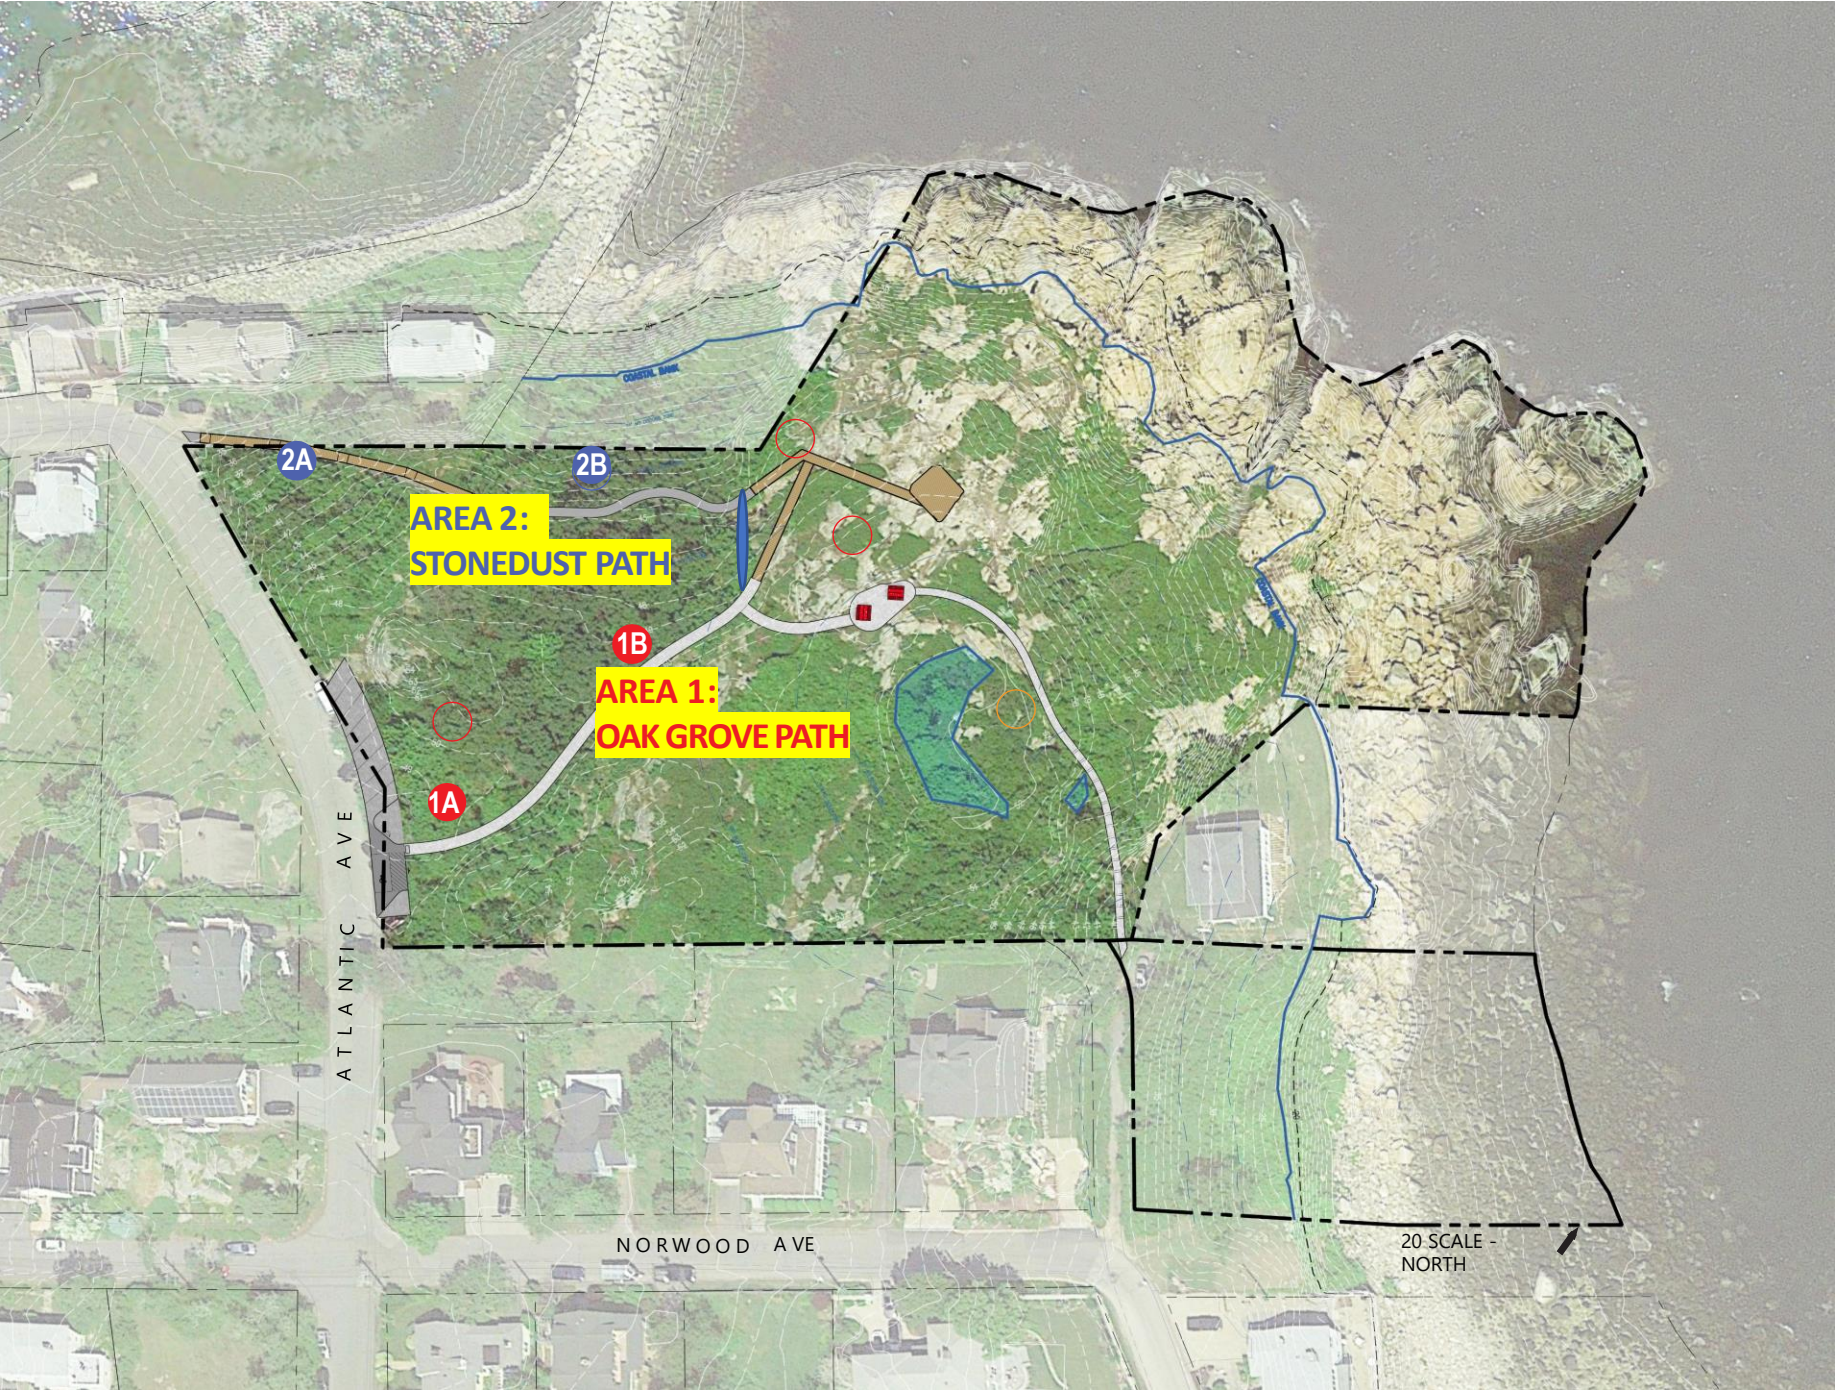
LEGEND

AREA 1: OAK GROVE PATH

- 1A ENTRY SIGN / CRUSHED STONE 60 DEGREE PARKING
- 1B STABILIZED STONEDUST PATH CONNECTS WITH PATH 2B

WILL BECOME PRIMARY ENTRANCE

AREA 2: STONEDUST PATH

- 2A & 2B PRIMARY ENTRANCE TODAY. ASPHALT SURFACE TO BE REPLACED WITH STABILIZED STONEDUST.
- CONNECTS WITH PATH 1B (SEE BLUE LINE)

- CREATE ORGANIZED + ACCESSIBLE PARKING OPTION
- IMPROVE AREA 1 AND AREA 2 PATHWAYS WITH BETTER SURFACES AND CUT BACK OVERGROWTH, DEAD BRANCHES AND BRIER BY 15 FEET
- CREATE A CONNECTION BETWEEN THE TWO PATHWAYS, 1B & 2B (SEE BLUE LINE)
- ENHANCE ENTRANCE AND PATHWAY SIGNS
- START THESE IMPROVEMENTS THIS YEAR

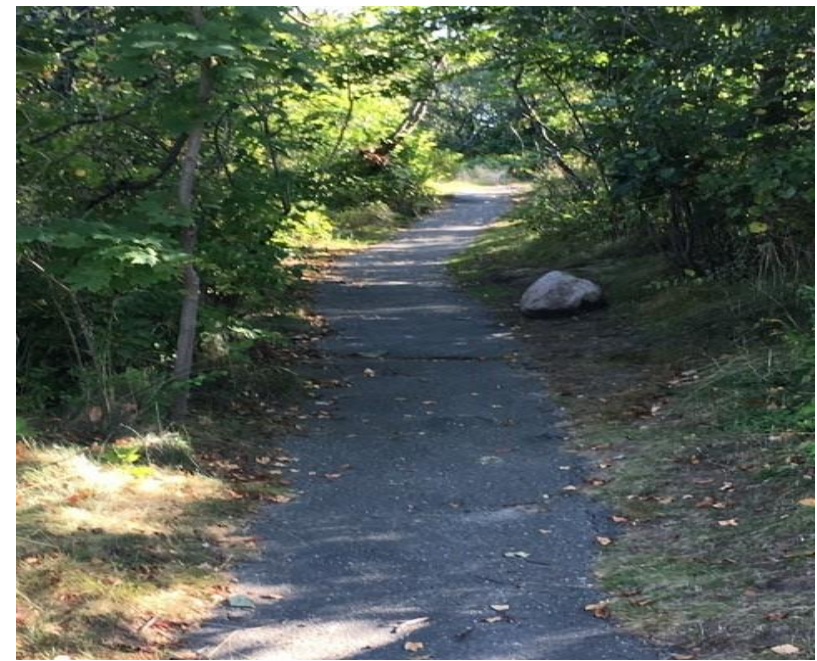
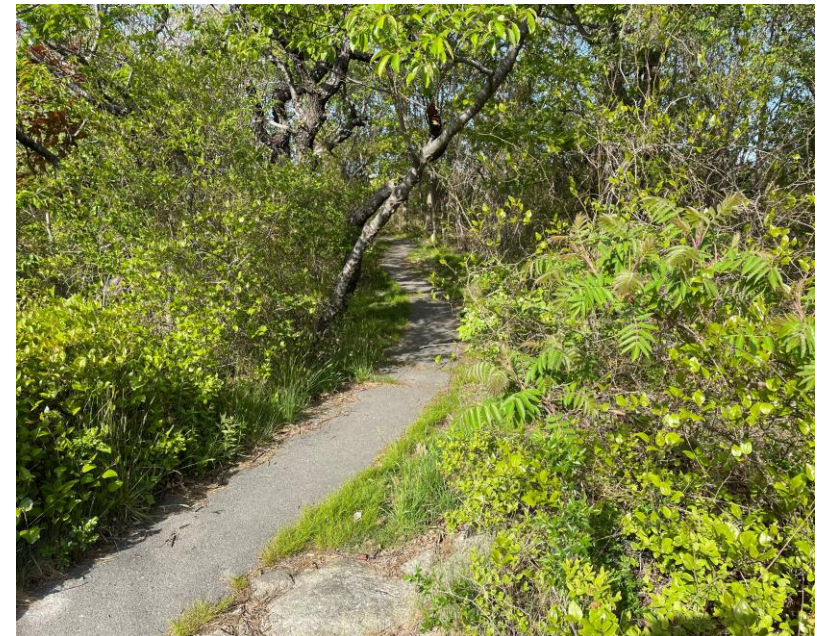
AREA 2

EXISTING PRIMARY PATH

NARROW OVERGROWN ASPHALT PATH

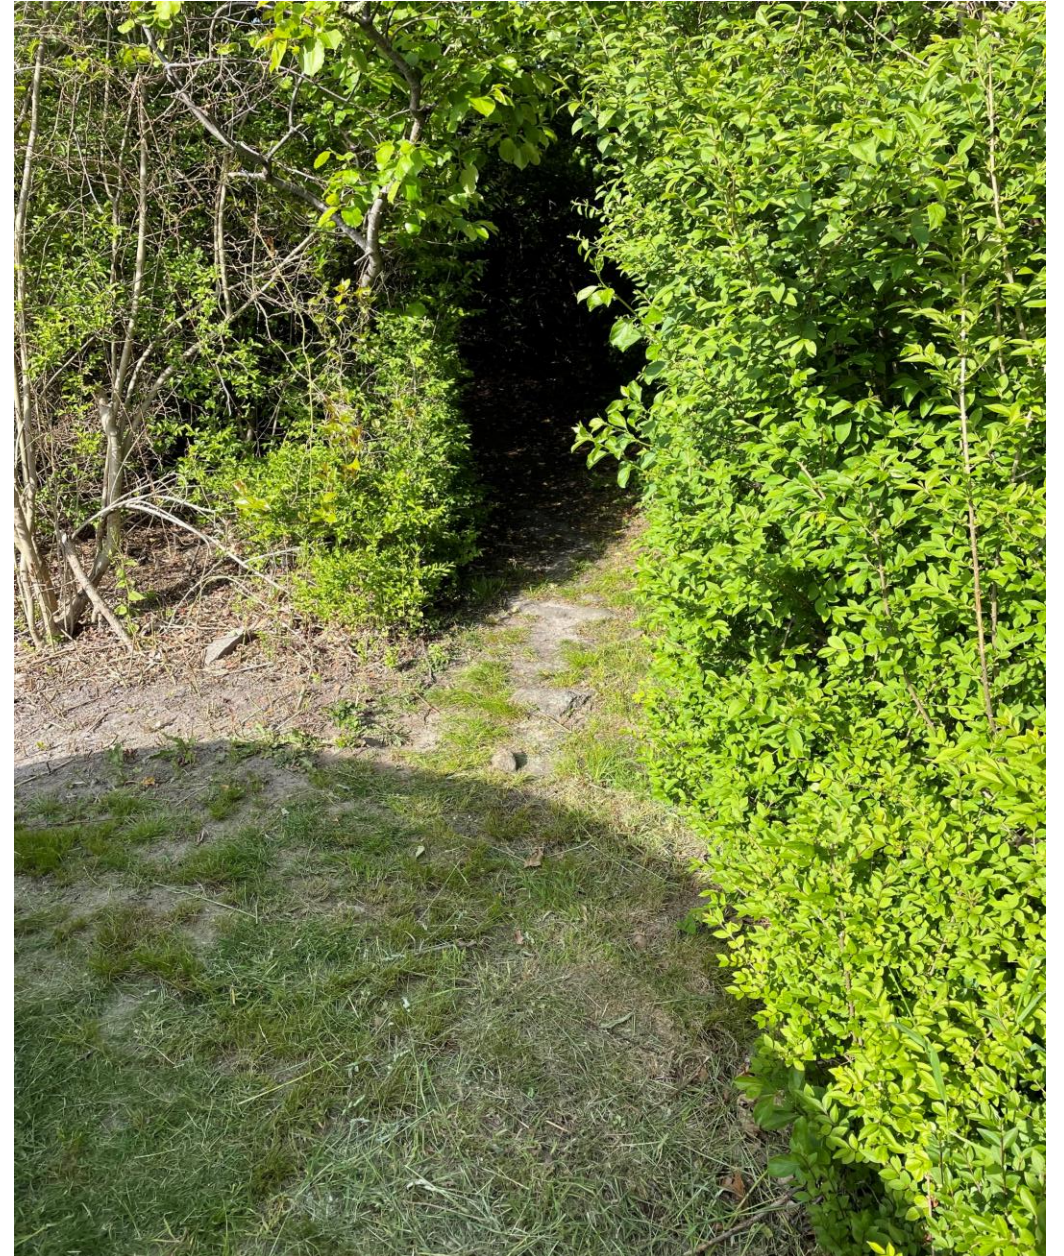
EXISTING BEGINNING OF OAK GROWTH PATH

STARTS AT PARKING AREA

- **PATH HAS FEWER INCLINES
THAN BOARDWALK PATH**
- **NEEDS SIGNIFICANT CUTTING
AND SURFACING**
- **NO WET OR ROCKY AREAS**

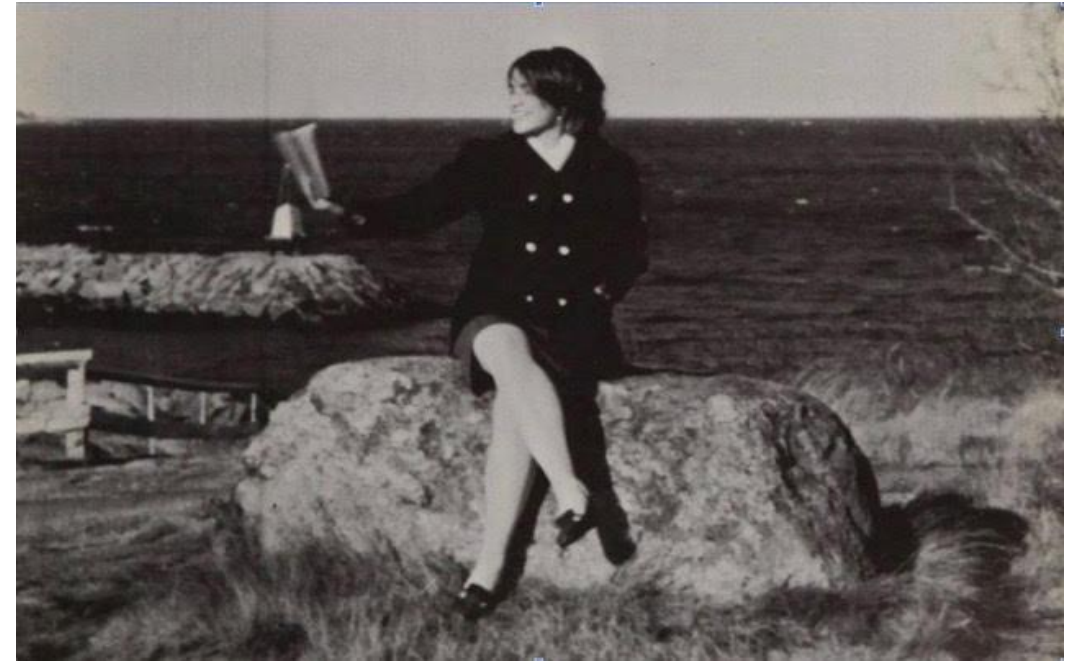
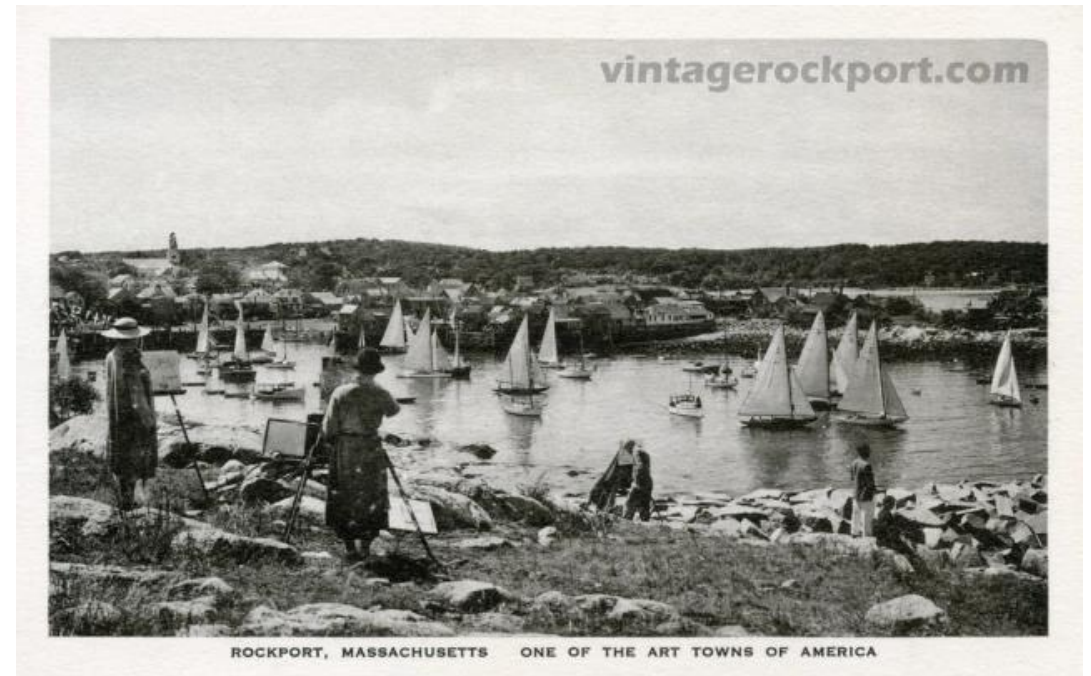
OLD PHOTOS

100 YEARS AGO, THE AREA WAS VERY OPEN

**VEGETATION AND UNDERGROWTH WERE ALLOWED TO
LIMIT THE AREA THAT CAN BE ENJOYED.**

**WE CAN'T FIND THE ROCK IN THE TOP PICTURE AS THE
VEGETATION IS TOO THICK TODAY.**

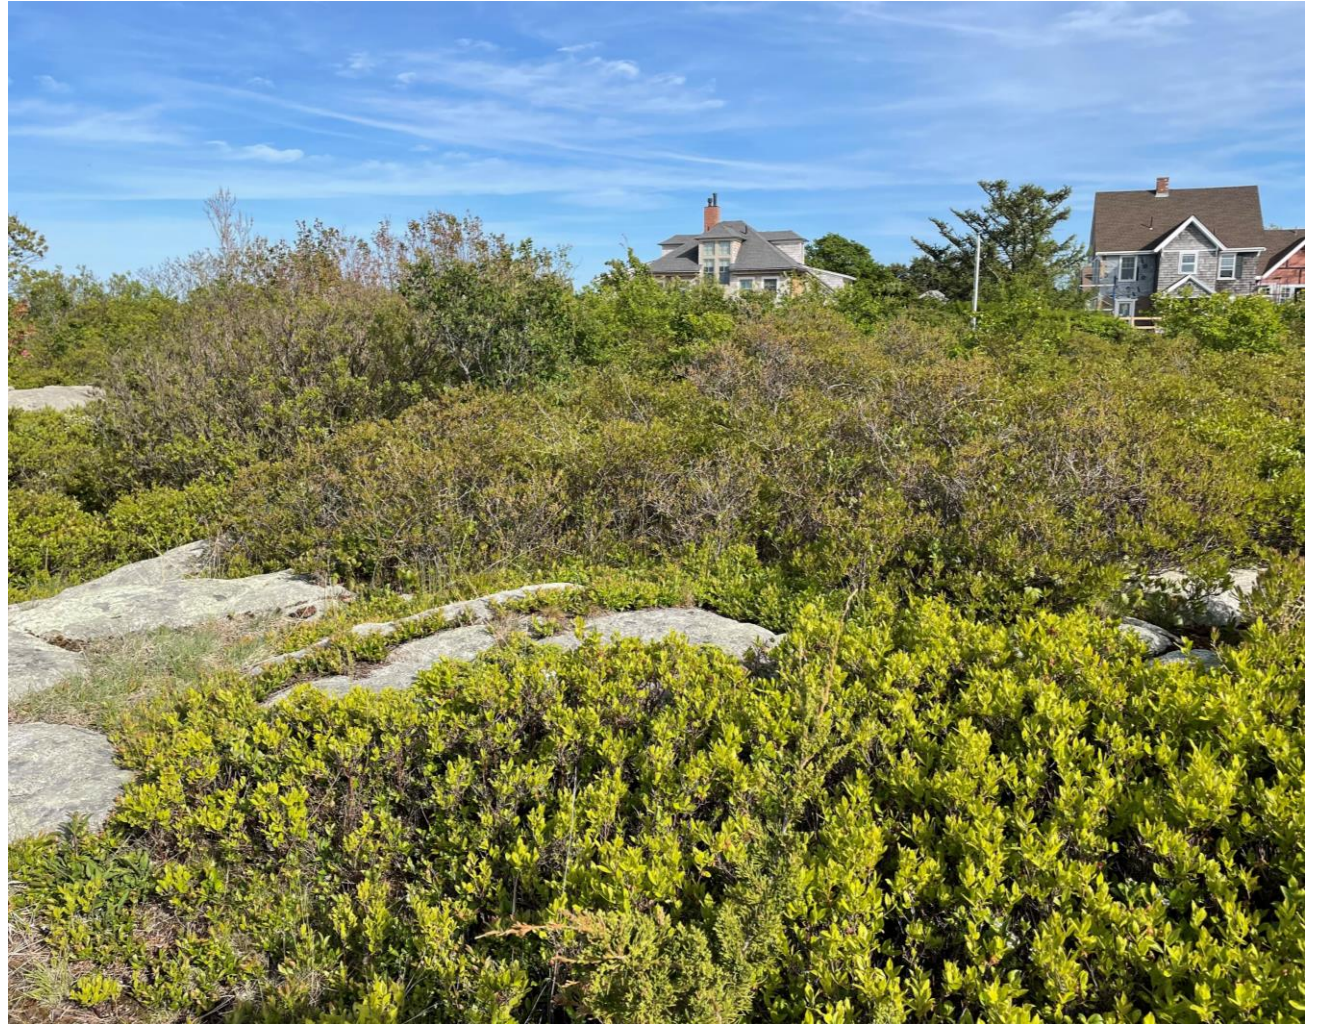
TOP OF THE HEADLANDS

**WILD BRIER UNDERGROWTH
MAKES THE MAIN AREA
UNUSEABLE**
